# Aeromotive, Inc. Case History, TB #102

**Re:** Tech Bulletin #102: Case File-A1000 Stealth Fuel Cell and Problem Outlet Filter.

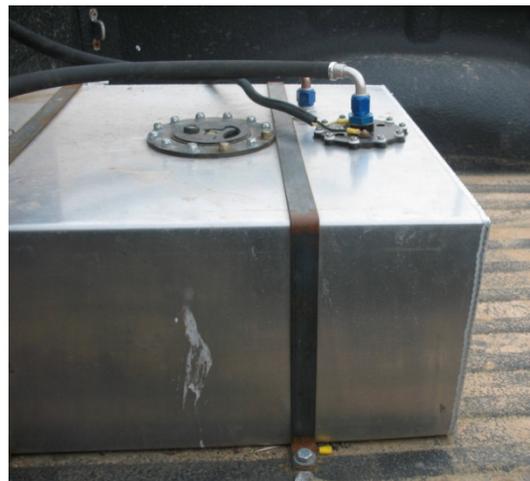
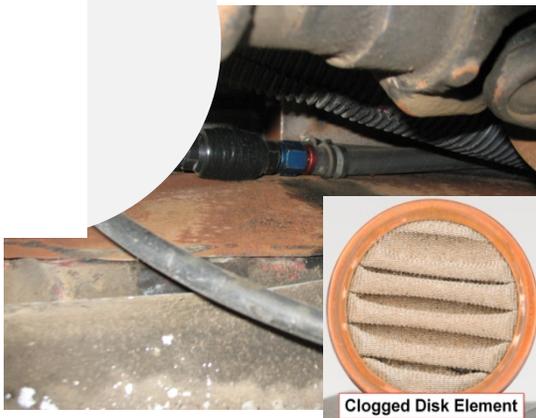
*On 04/01/2010, a customer contacted the Aeromotive Tech Department reporting problems with a recently installed A1000 Stealth Fuel Cell. The complaint was that, with only 2,500 miles on the system, the fuel pump became extremely noisy after 15 minutes of driving followed by rapid fluctuation of fuel pressure that would then fall to zero. Once this happened the engine quit and could not be started or driven for 30 minutes or more.*

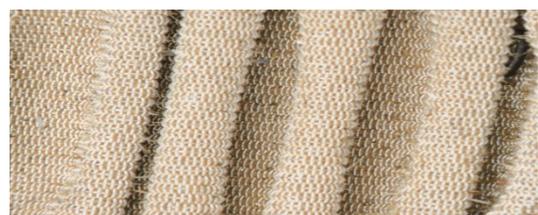
With a description of the installation and pictures of the general setup to help with trouble shooting, the problem appeared to be an off-brand fuel filter, after the pump, which in 2,500 miles had become completely clogged due to insufficient surface area. For testing purposes the element was removed from the filter housing, after which the system performed better, but still exhibited similar problems. It was determined the pump was probably damaged and an RGA as setup to get it, and the suspect filter, back here for inspection by factory technicians.

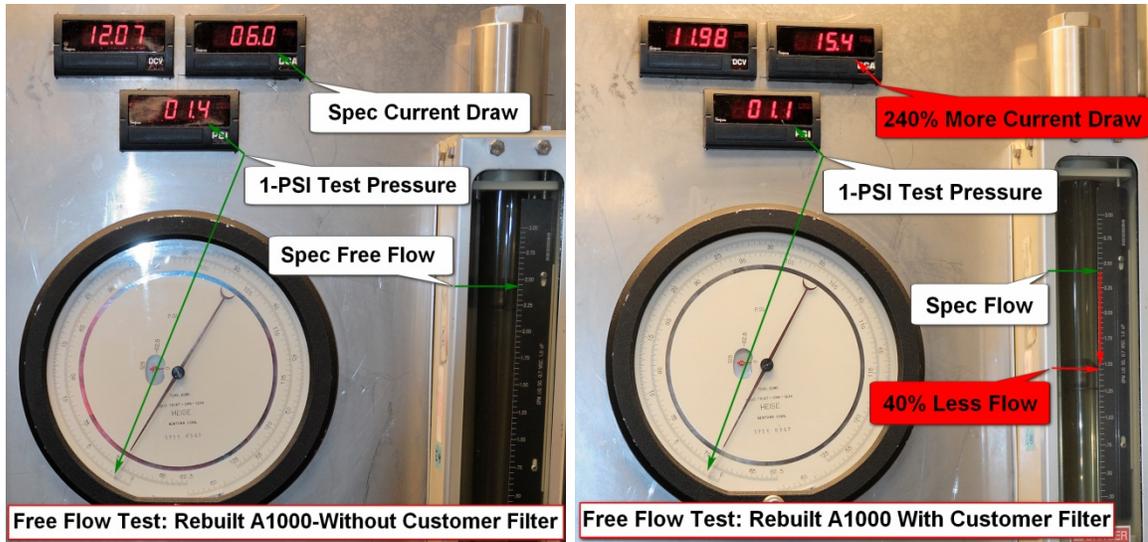
With the A1000 back at the factory, we put it on the test stand: ***It was immediately clear pump performance was flagging, with under-spec flow at pressure and abnormally high current draw.*** Upon disassembly the technician found permanent damage resulting from extended operation at extremely high pressure. We repaired the A1000 as a manufacturer's courtesy and then reinstalled it on the test stand, where it once again performed as new.

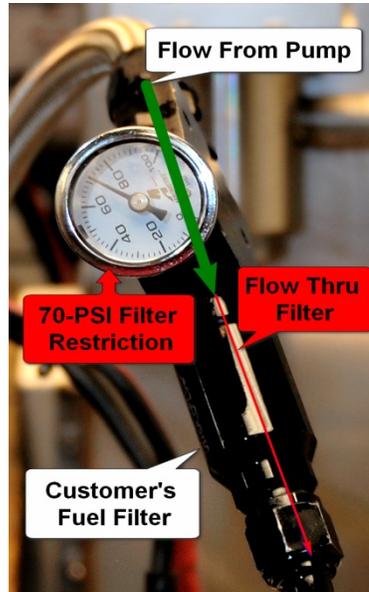
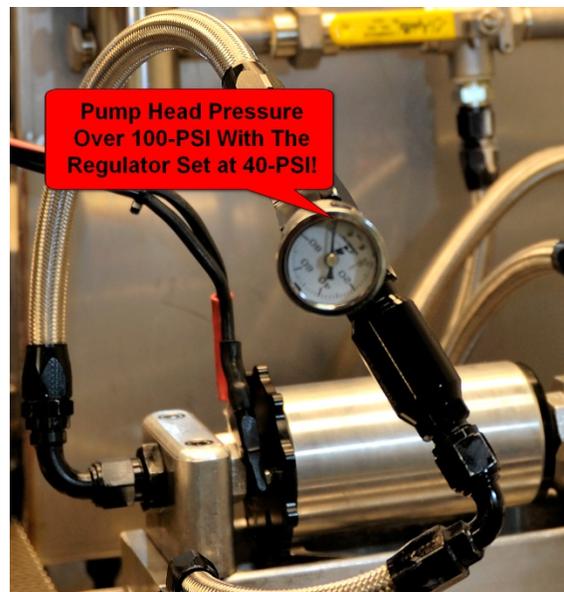
With the A1000 pump back up to snuff the customer's filter was installed after the fuel pump, just as it had been installed on the vehicle, in order to validate our theory of what the problem was. As we suspected, fuel pump performance was immediately and significantly degraded.

***In fact, the restriction created by the filter was so high that back-pressure at the pump went from under 2 PSI Free-Flow to over 70 PSI trying to push through the small, clogged filter element!***

***Setting the down-stream pressure up to a typical EFI level of 40 PSI brought pressure before the filter up to over 100 PSI! No wonder there was damage. Lessons learned?***  
A.) Install a genuine Aeromotive fuel filter after the fuel pump (See Tech Bulletin #102).  
B.) Monitor filter condition, especially in new systems, to ensure the element is clean and free flowing, thus preventing drivability problems and protecting instead of harming the pump.
