Aeromotive, Inc. Case History, TB #102

Re: Tech Bulletin #102: Case File-A1000 Stealth Fuel Cell and Problem Outlet Filter.

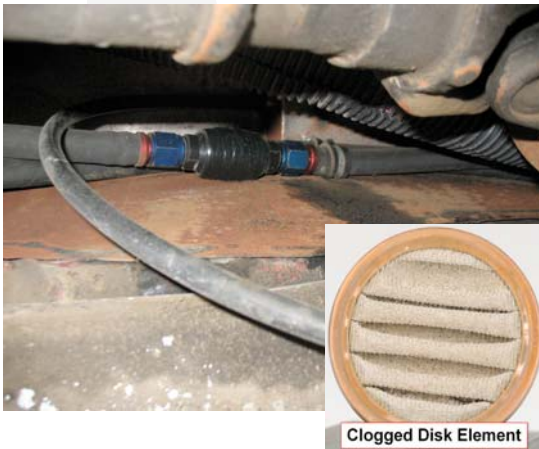
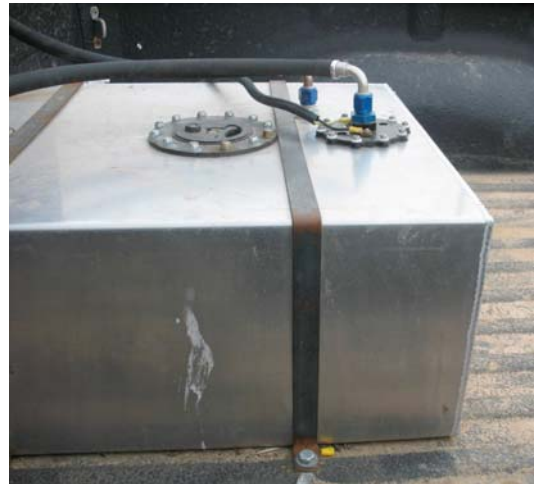
On 04/01/2010, a customer contacted the Aeromotive Tech Department reporting problems with a recently installed A1000 Stealth Fuel Cell. The complaint was that, with only 2,500 miles on the system, the fuel pump became extremely noisy after 15 minutes of driving followed by rapid fluctuation of fuel pressure that would then fall to zero. Once this happened the engine quit and could not be started or driven for 30 minutes or more.

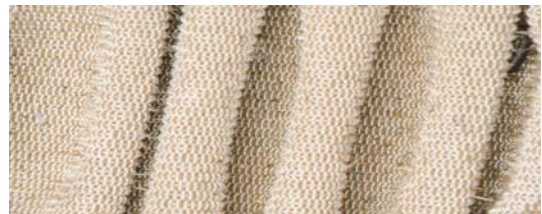
With a description of the installation and pictures of the general setup to help with troubleshooting, the problem appeared to be an off-brand fuel filter, after the pump, which in 2,500 miles had become completely clogged due to insufficient surface area. For testing purposes the element was removed from the filter housing, after which the system performed better, but still exhibited similar problems. It was determined the pump was probably damaged and an RGA was setup to get it, and the suspect filter, back here for inspection by factory technicians.

A.) Install a genuine Aeromotive fuel filter after the fuel pump (See Tech Bulletin #102).
B.) Monitor filter condition, especially in new systems, to ensure the element is clean and free flowing, thus preventing drivability problems and protecting instead of harming the pump.

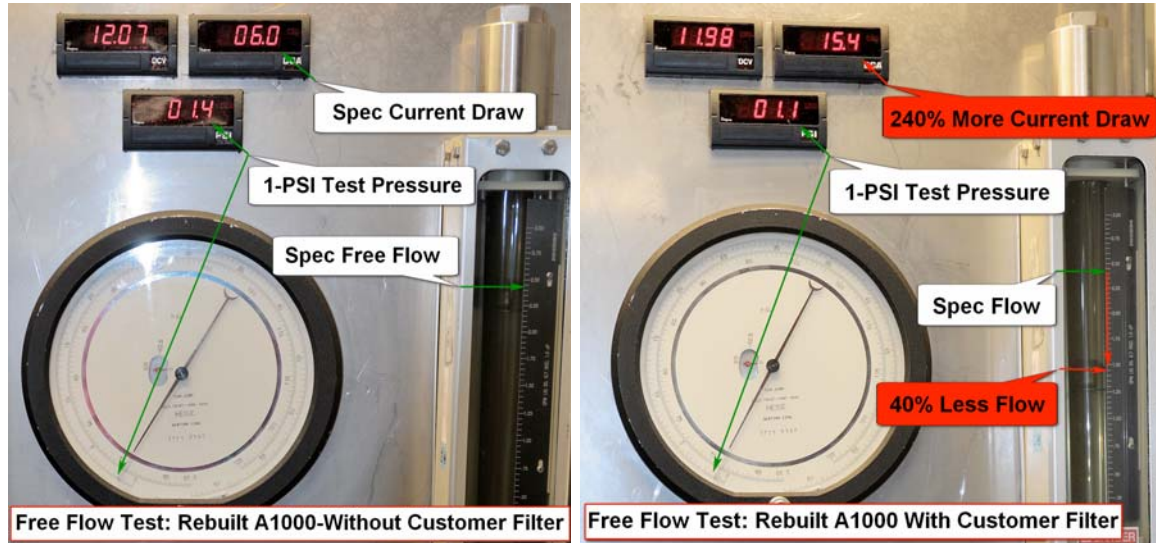
With the A1000 back at the factory, we put it on the test stand: ***It was immediately clear pump performance was flagging, with under-spec flow at pressure and abnormally high current draw.*** Upon disassembly the technician found permanent damage resulting from extended operation at extremely high pressure. We repaired the A1000 as a manufacturer's courtesy and then reinstalled it on the test stand, where it once again performed as new.

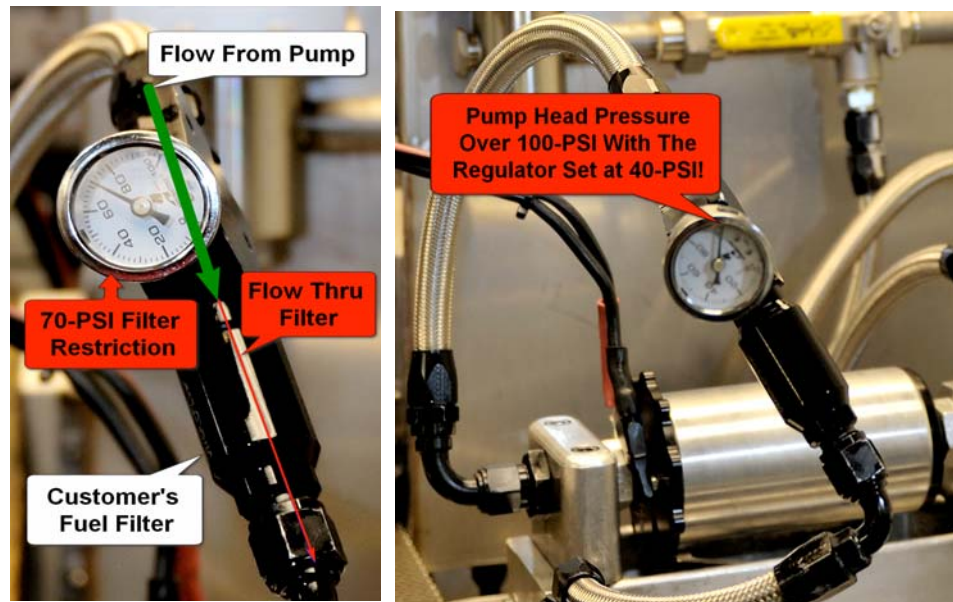
With the A1000 pump back up to snuff the customer's filter was installed after the fuel pump, just as it had been installed on the vehicle, in order to validate our theory of what the problem was. As we suspected, fuel pump performance was immediately and significantly degraded.

In fact, the restriction created by the filter was so high that back-pressure at the pump went from under 2 PSI Free-Flow to over 70 PSI trying to push through the small, clogged filter element!

Setting the down-stream pressure up to a typical EFI level of 40 PSI brought the operating pressure before the filter to over 100 PSI! No wonder there was damage. Lessons learned?
